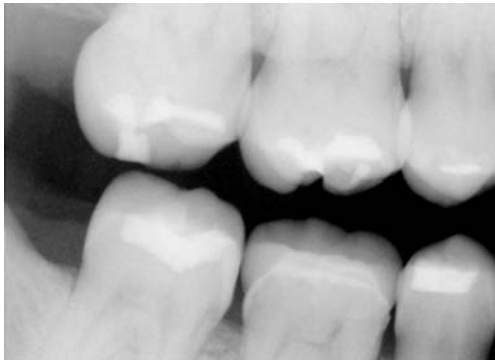
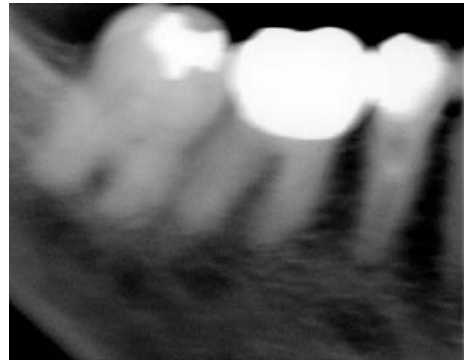
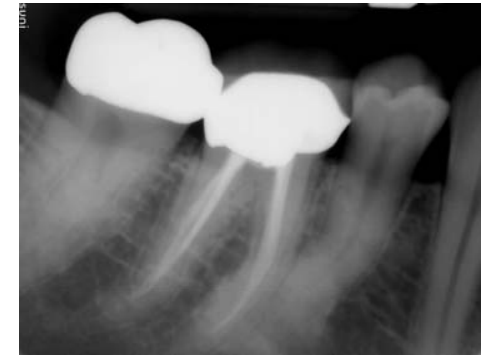
BLURRINESS

- Could cause by movement from X-ray head
- Compress the image by using BINNED in CCD does the trick
- Ambient light or direct sun light
- Some just have certain degree of blurriness depends on the machine being calibrated
- Increase integration time, especially with the AC head machine

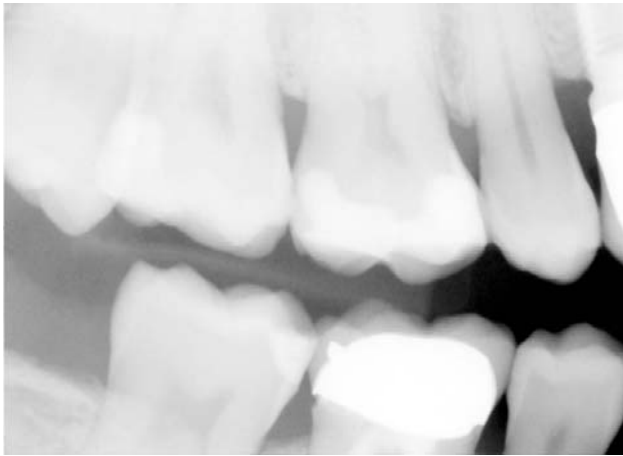
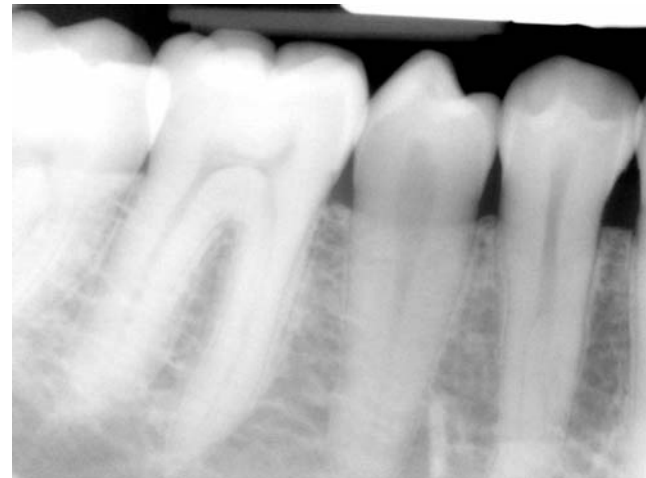
LIGHT, WASHED OUT, GRAINY

- Increase exposure – Especially on Belray machine or some machine with low mA
- Change image return type to BINNED if CCD sensor
- Apply filter – Lowering the brightness, increase contrast and combine with gamma usually gives best result.
- Increase contrast or use the SMOOTH operation

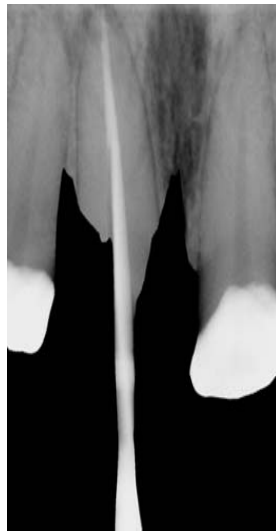
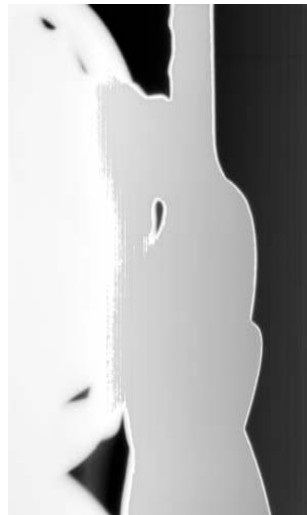
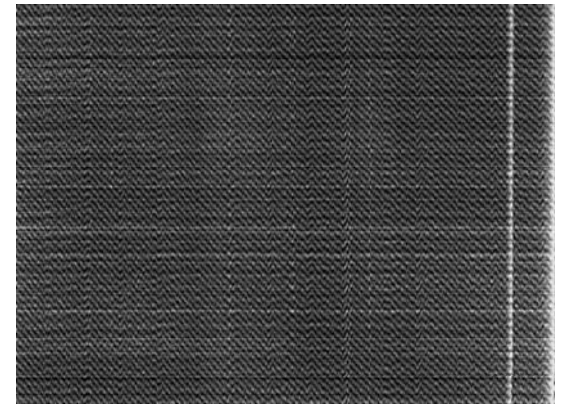
BURNED-OUT, OVER EXPOSED

- Over exposed, lower the exposure

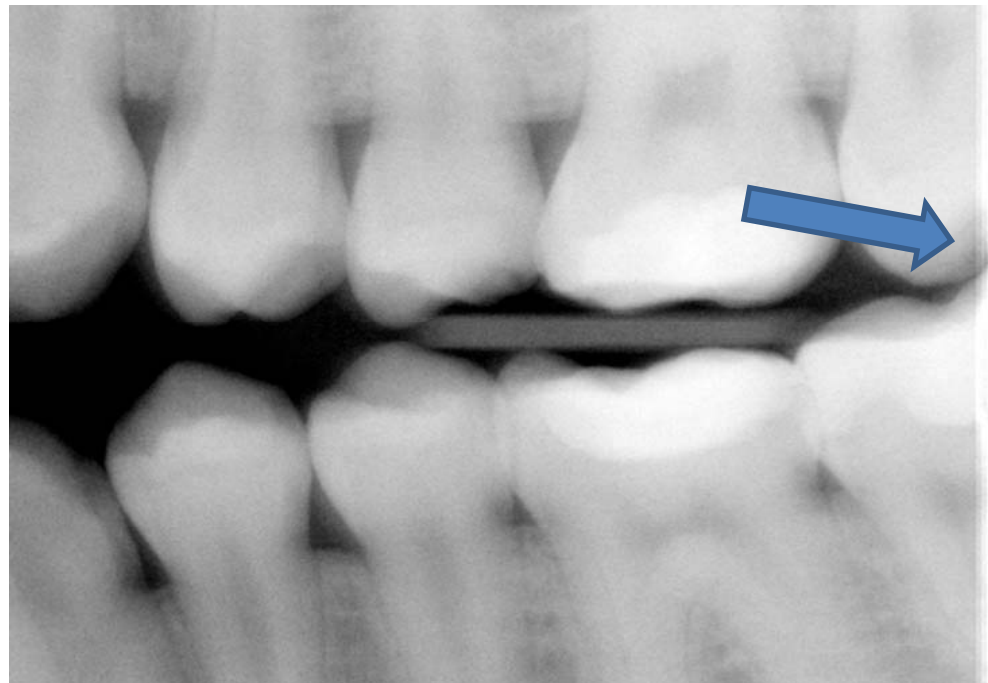
STAIR STEPPING

- Mostly cause by AC head machine – they usually take longer for radiation to penetrate, therefore, increase integration time until no fuzziness appear
- For older 1800 box, apply stair stepping fixed .mcs file

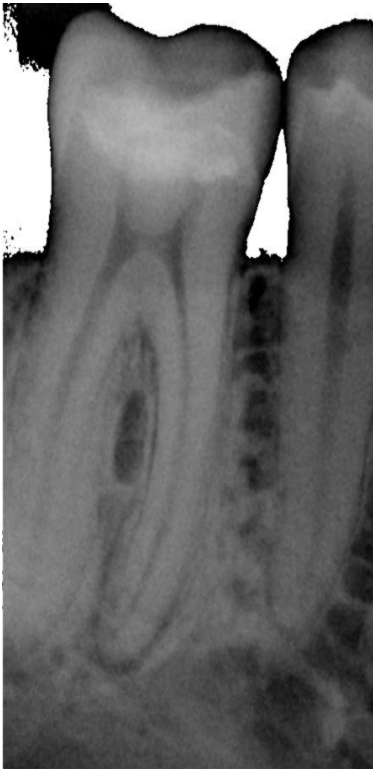
DISTORTED

- So far, this hasn't happen with SuniRay sensor
- For CCD with 1800, it happens on BINNED setting with certain(type) X-ray machine

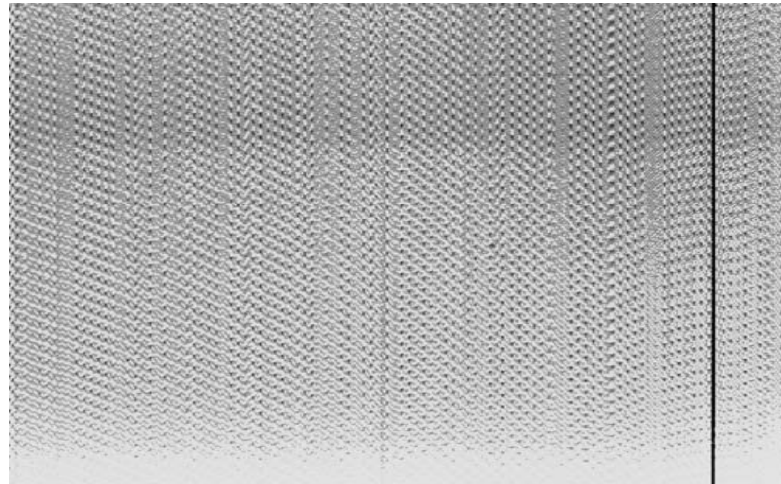
STITCH PATTERN

- Over exposed on some SuniRay sensors

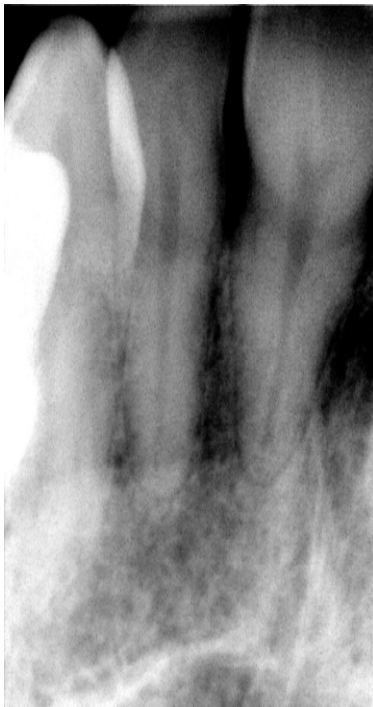
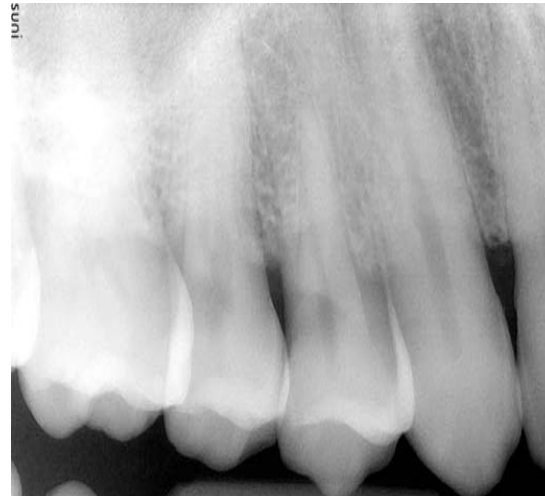
NOISY IMAGE

- Typically, it causes by under exposed or the cone too far from the sensor.
