Troubleshooting Guide

Table of Content

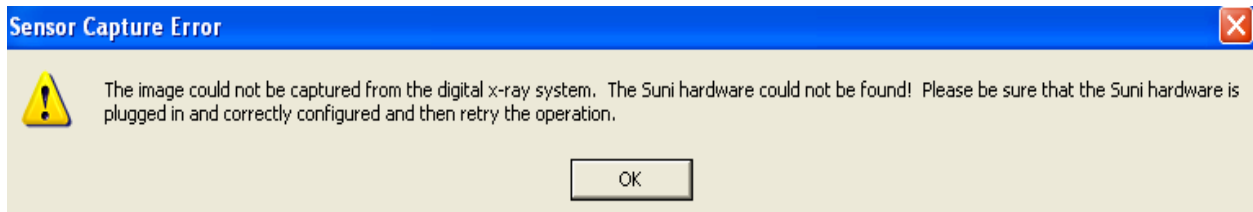
After position the sensor and activate the unit, the following message is displayed.

This error message can be generated in one of the following situations:

- a) The USB 2000 box is not recognized by the computer
- b) The USB 2000 driver is not installed
- c) Dr. Suni Plus sensor is not properly plugged in
- d) The USB 2000 firmware files need to be updated

- a) The USB 2000 box is not recognized by the computer
 - Make sure the USB 2000 box is plugged in to the back USB port and the computer recognized the hardware.
 - Check the Windows Device Manager to verify if the USB driver was installed successfully.

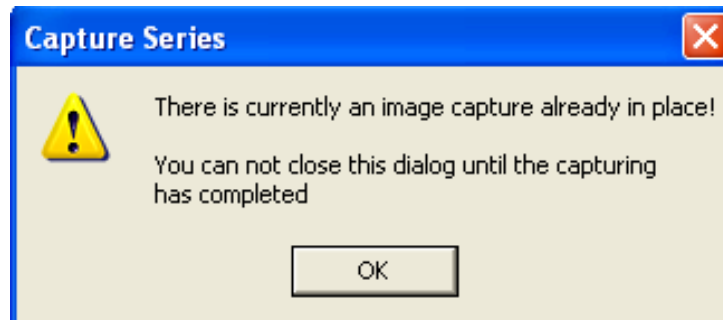
When trying to switch sensor or stop in the middle of layout capturing, the following message is displayed:

User did not quit image captures properly or completed the previous captures before closing it.

Finish the image capturing or stop layout series properly by clicking on the red 'X' on the lower bottom left hand corner to abort capturing.

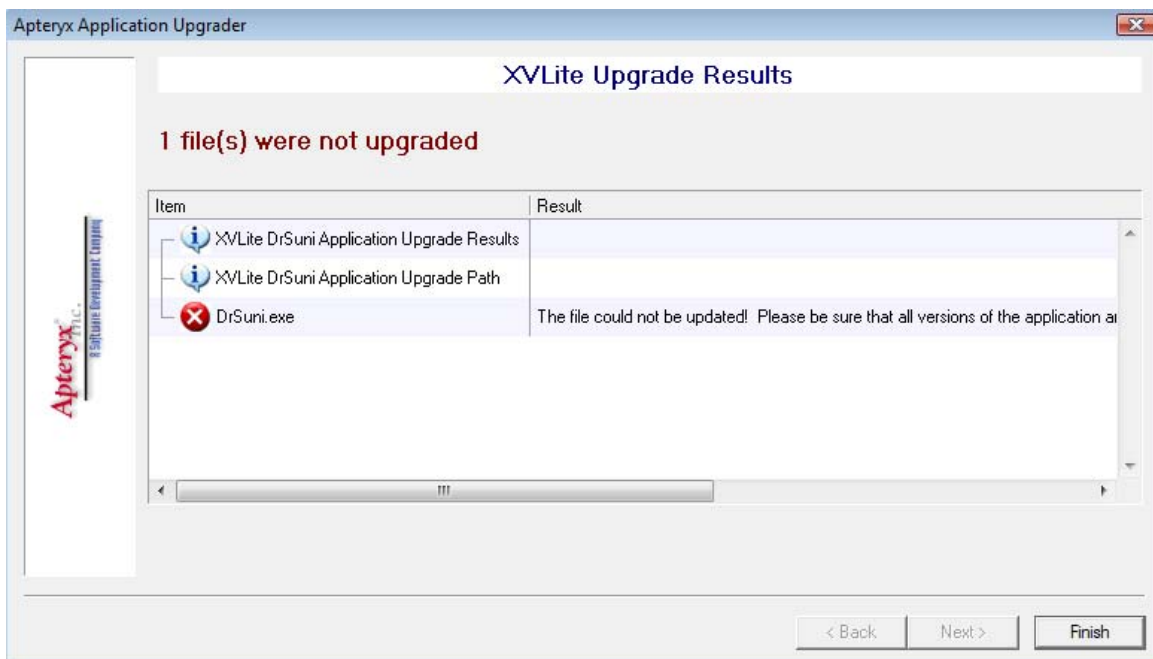
After downloading the software upgrader and trying to run it, the following message is displayed.

Make sure Prof. Suni program is closed in all computers (local and network) before running the software upgrader.

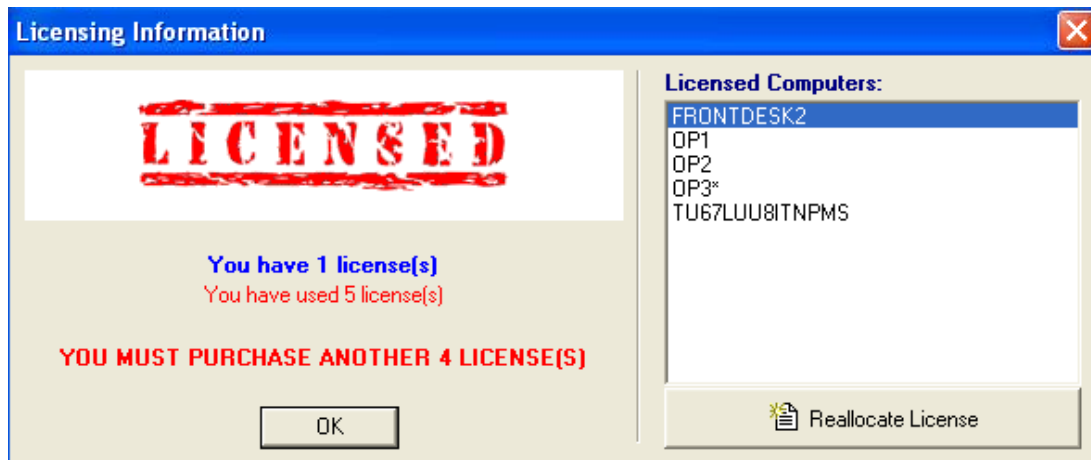
When starting Prof.Suni, licensing warning information is displayed.

The user has used/exceeded the number of licenses were purchased for the software.

To resolve licensing problem, the user must either purchase additional licenses or reallocate previously allocated license by selecting license from the **Licensed Computers** listing and then click on **Reallocate License** button.

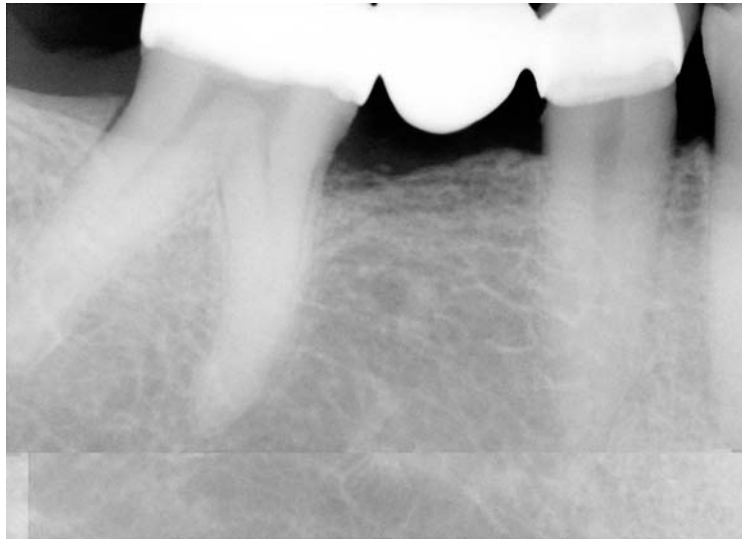
Sample grainy image:

Image appears to be too light, grainy and lack of contrast.

Grainy (or “noisy”) image generally caused by underexposed.

- a) Increase the exposure setting from the X-ray unit, and/or decrease the distance between the unit and the sensor.
- b) Use the image enhancement tools – **Brightness and Contrast**. In general, brightness/contrast enhancement changes the brightness and

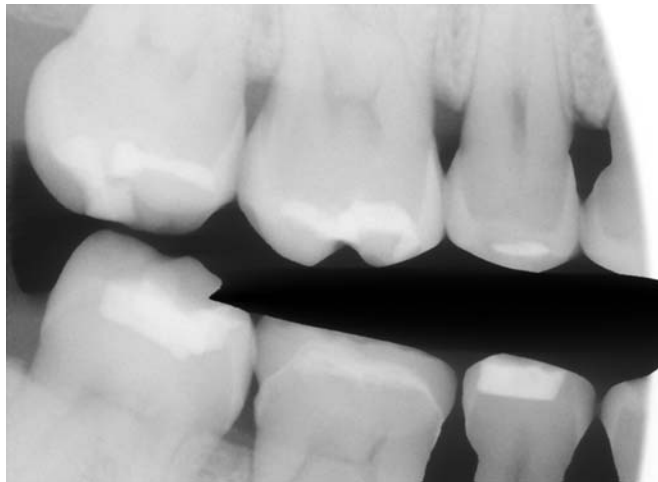
Sample burned-out image:

Image appears to be too dark, or teeth appear to be jagged.

Dark (or “burned-out) image generally causes by over exposed.

Try turning the radiation down a notch. Most sensors operate best at a time of between 0.08 seconds (about 5 pulses) to 0.16 seconds (9 – 10 pulses). A usual good starting point is at 70kVp, 7mA and 0.10 seconds (6 pulses), and then go up or down one notch at a time from there.

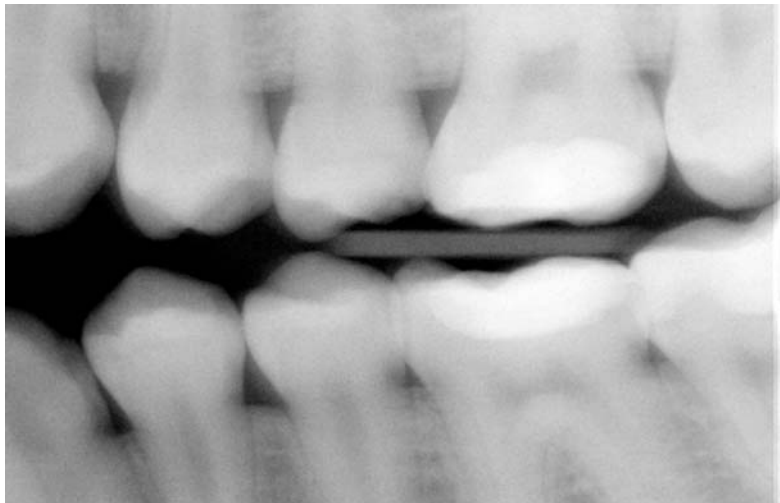
Sample “stair-stepping” image:

Stripes appear on the edge of the image, or “stair-stepping”.

Longer warm up pulses from certain AC-head machine.

Go to **Tools**→**Options**→**Sensor**→**SuniUSBII**→**Detection and Sensitivity** and then increase the integration time by a step of 50ms until no stripes is observed.
