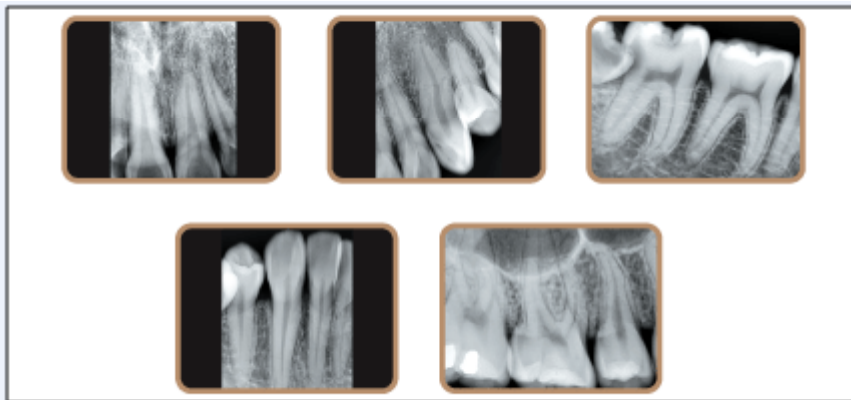
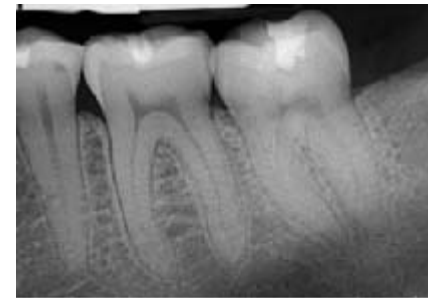
- Could cause by movement from X-ray head
- Compress the image by using BINNED in CCD does the trick
- Ambient light or direct sun light
- Some just have certain degree of blurriness depends on the machine being calibrated
- Increase integration time, especially with the AC head machine
