Troubleshooting Guide

Table of Content

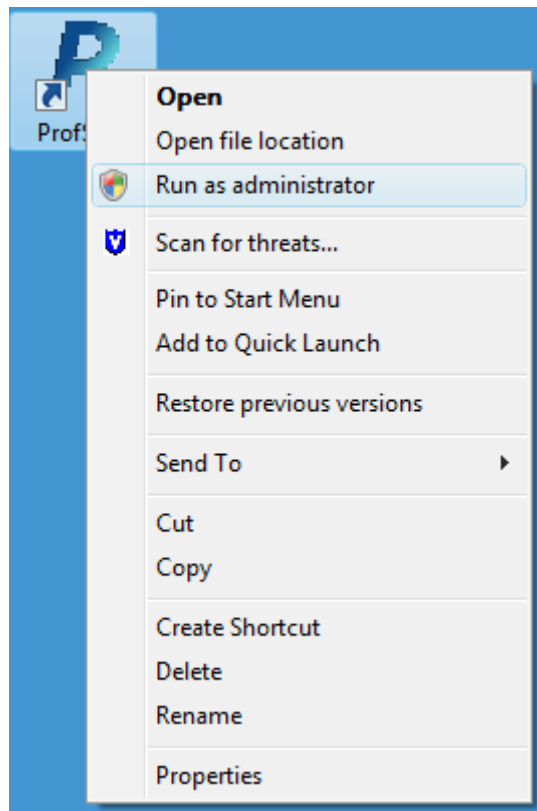
After registering the software in Vista, and re-launches the program, it asks for registration information again.

The problem occurs because the user does not have the administrative privileges necessary to create registration information. To properly register the software, the user should right click on ProfSun.exe and choose 'Run as administrator'.

Re-enter the registration number 9C50-685A-****, user information and skip STEP 2: ACTIVATION CODE, then click **DONE** to access the program.

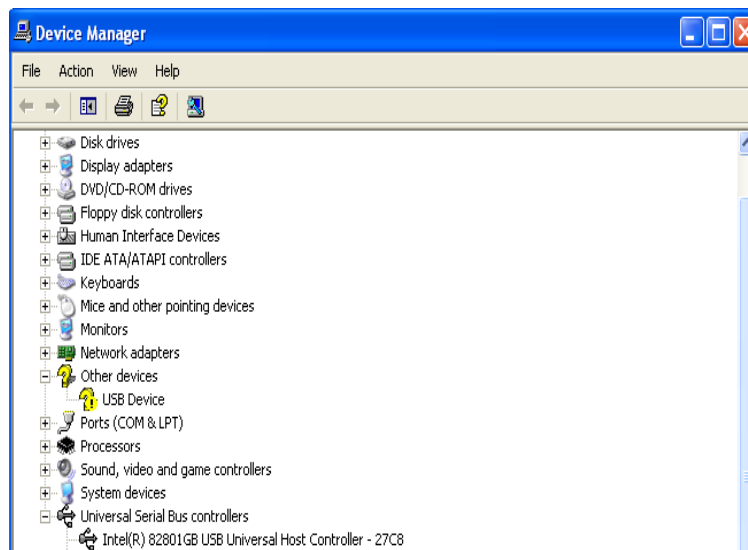
- If the USB 2000 driver was NOT properly installed, a device named **USB device** marked with a yellow exclamation mark will appear under **other devices**.

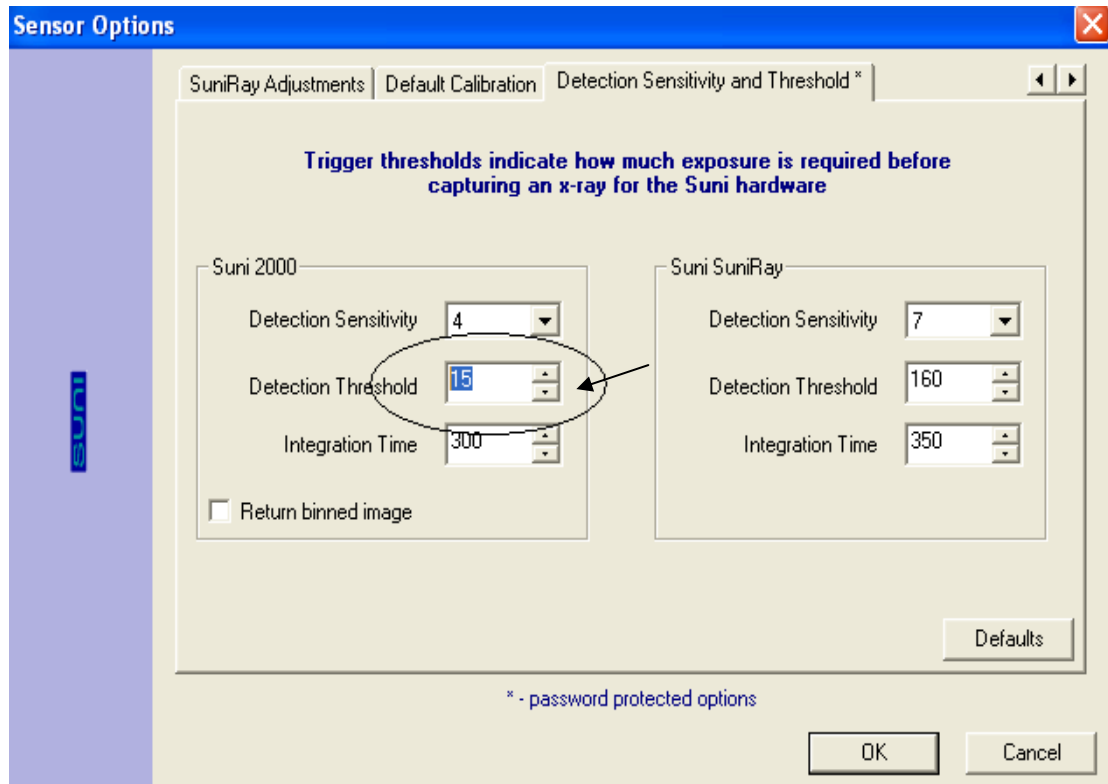
The sensor triggers by itself without any radiation induces.

- a) Sensor enclosure splitting/opening
- b) Sensor cable(internal) or connector damaged
- c) Connector on USB 2000 box bad
- d) Noise Interference

- Go to **Tools**→**Options**→**SuniUSBII**→**Detection Sensitivity and Threshold**, increase threshold value by 2 until no self-trigger is observed.

(Default is 15)

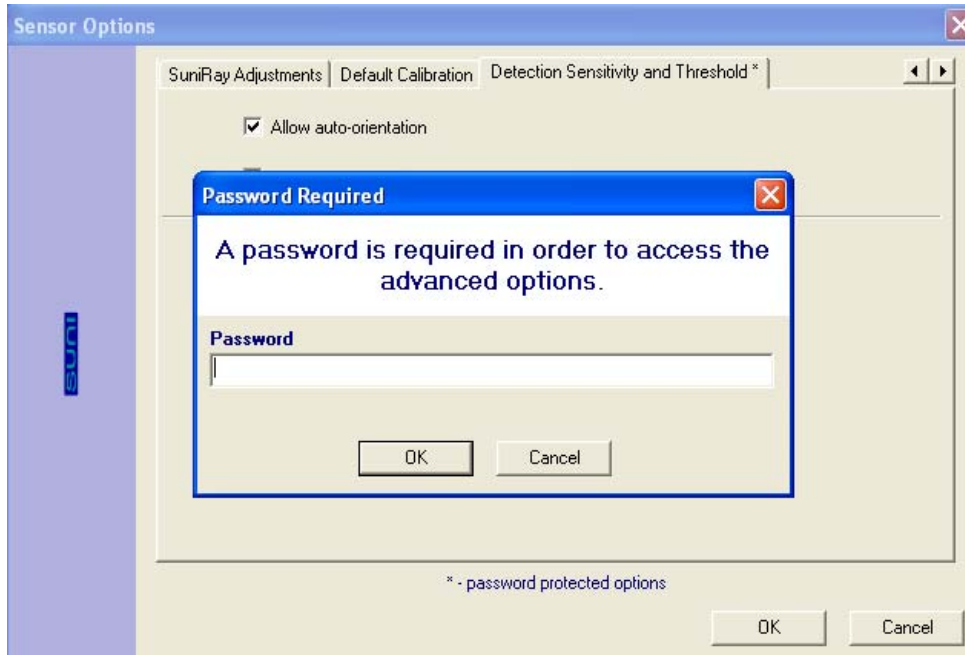
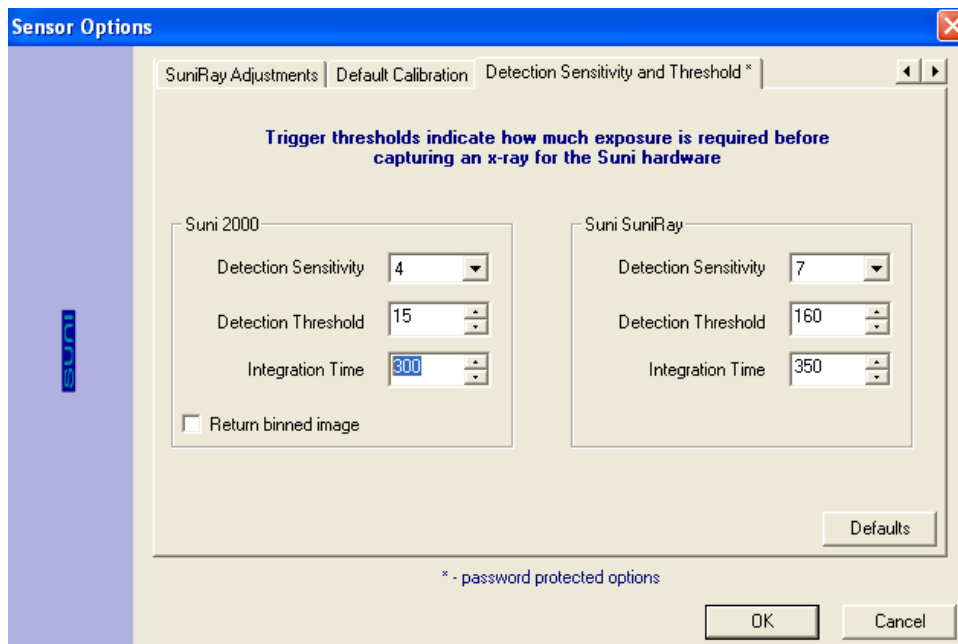
Stripes appear on the edge of the image, or “stair-stepping”.

Longer warm up pulses from certain AC-head machine.

Go to **Tools**→**Options**→**Sensor**→**SuniUSBII**→**Detection and Sensitivity** and then increase the integration time by a step of 50ms until no stripes is observed.
