Troubleshooting Guide

I: Licensing / Registration

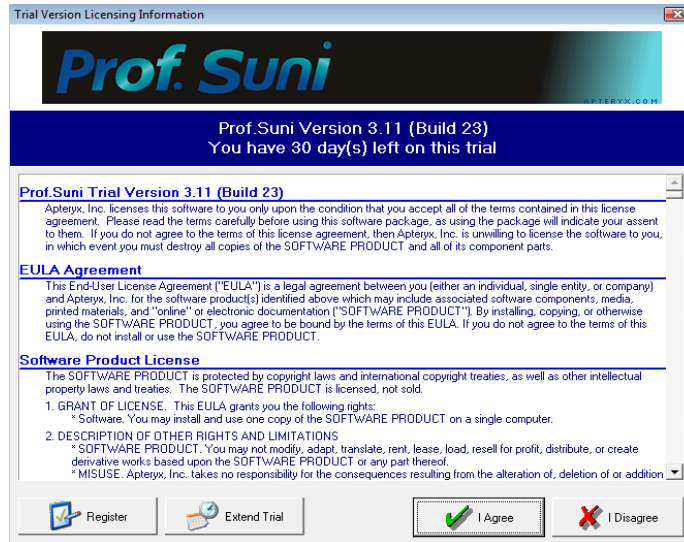
After launching ProfSuni from the icon onto your desktop, you will see the following: Trial Version Licensing Information screen.

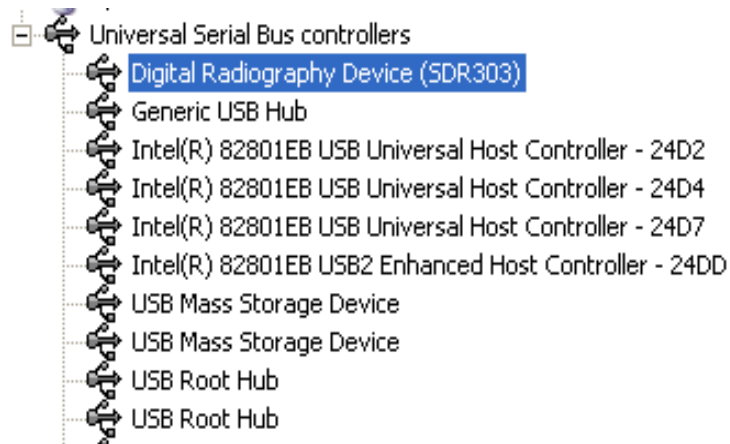
- a) The Suniray USB is not recognized by the computer
 - Make sure the Suniray sensor is plugged in to the back USB port and the computer recognized the hardware.
 - Check the Windows Device Manager to verify if the USB driver was installed successfully.

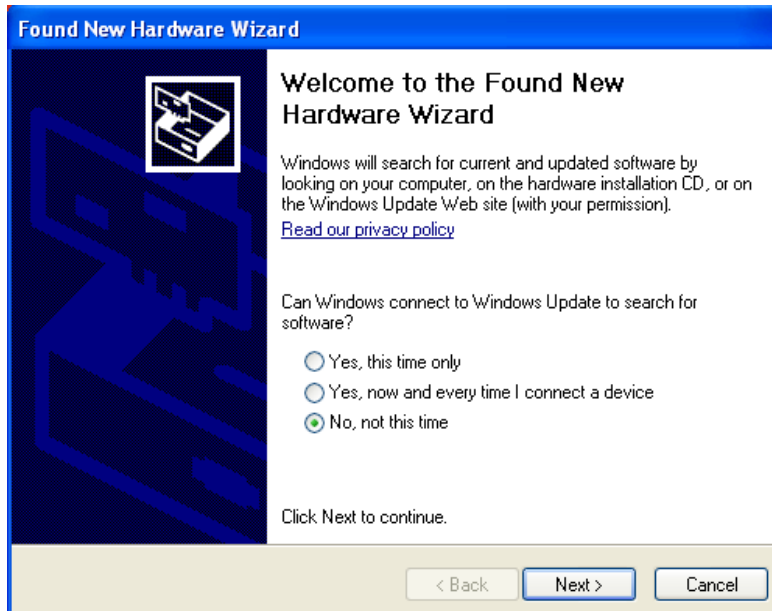
- Insert the ProfSuni disc in the CD-ROM drive. //The driver is in <D:\Drivers\SDR303>
- Double click on **USB Device** in **Other devices** then follow the 'Found New Hardware' wizard to install the driver.

- Follow the prompts to finish the driver installation, when it's done successfully, Digital Radiography Device (SDR303) should be listed under Device Manager.

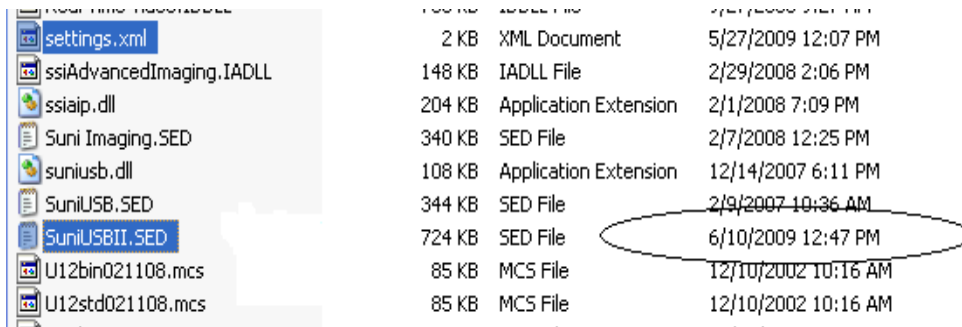
- Right click on ProfSuni.exe icon on desktop, select Properties→Find Target and make sure the SuniUSBII.SED file is dated 6/10/09 or newer.

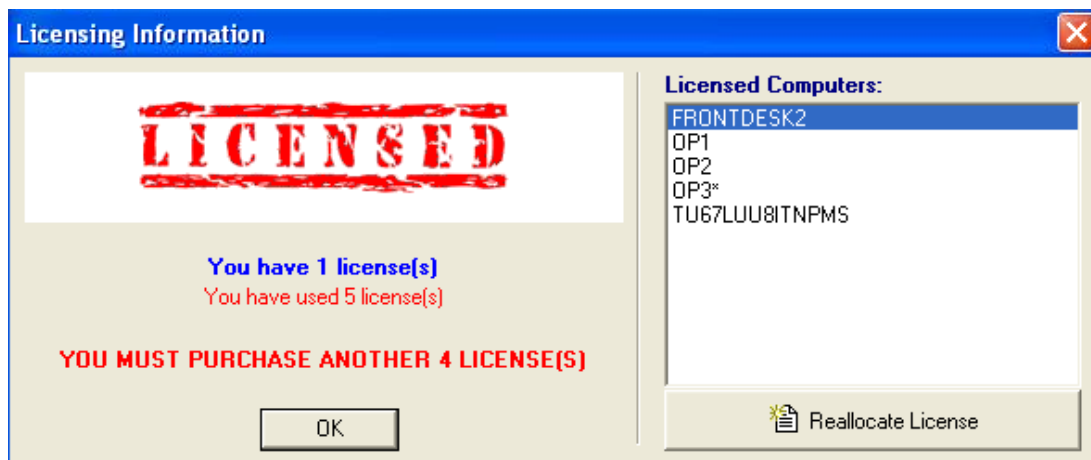
When starting ProfSuni, licensing warning information is displayed.

To resolve licensing problem, the user must either purchase additional licenses or reallocate previously allocated license by selecting license from the **Licensed Computers** listing and then click on **Reallocate License** button.

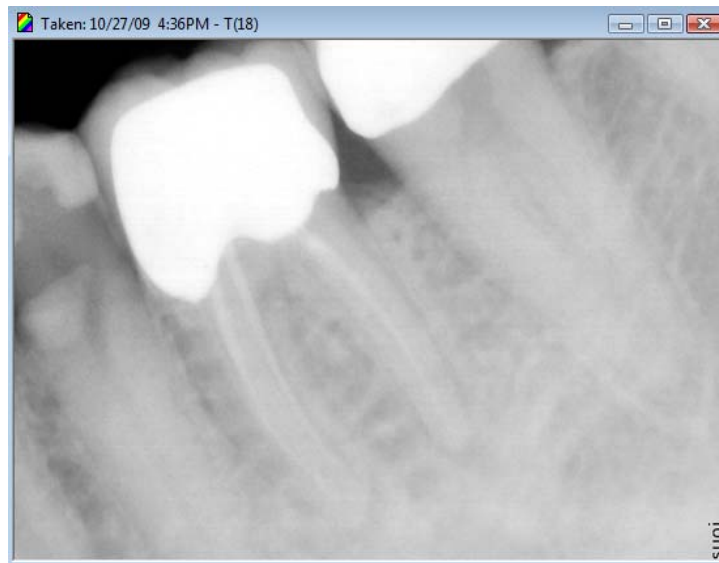
Sample grainy image:

Image appears to be too light, grainy and lack of contrast.

Grainy (or “noisy”) image generally caused by under exposure.

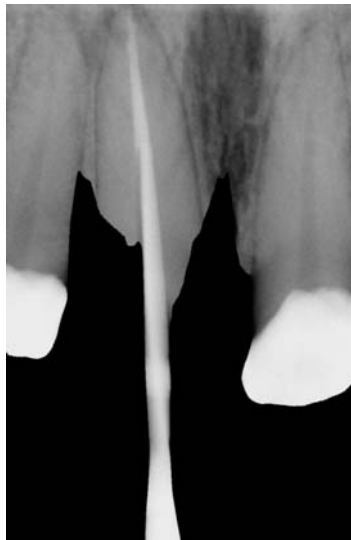
Sample burned-out image:

Image appears to be too dark, or teeth appear to be jagged.

Dark (or “burned-out) image generally caused by over exposure.

Try turning the radiation down a notch. Most sensors operate best at a time of between 0.06 seconds (about 4 pulses) to 0.10 seconds (6 pulses). Usually, a good starting point is at 70kVp, 7mA and 0.06 seconds (about 4 pulses), and then go up or down one notch at a time from there.

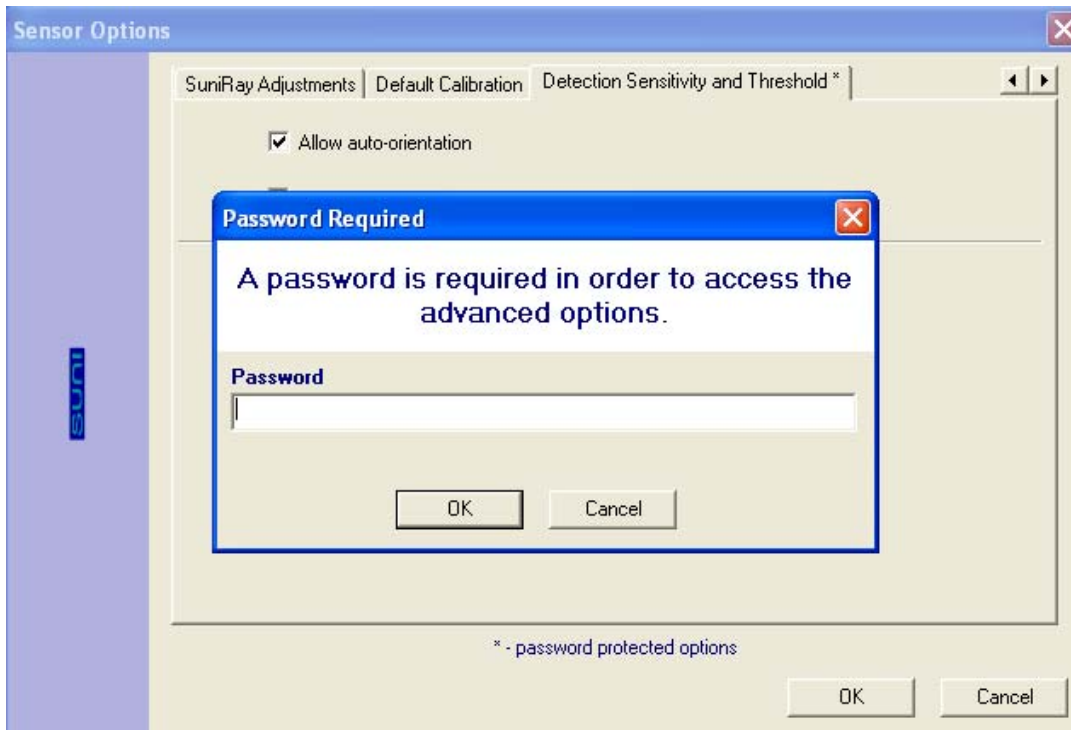
Go to **Tools**→**Options**→**Sensor**→**SuniUSBII**→**Detection and Sensitivity** and then increase the integration time by a step of 50ms until no stripes is observed.

- a) Use the same method on page 20 to increase the integration time
- b) Make sure no movement from the x-ray source

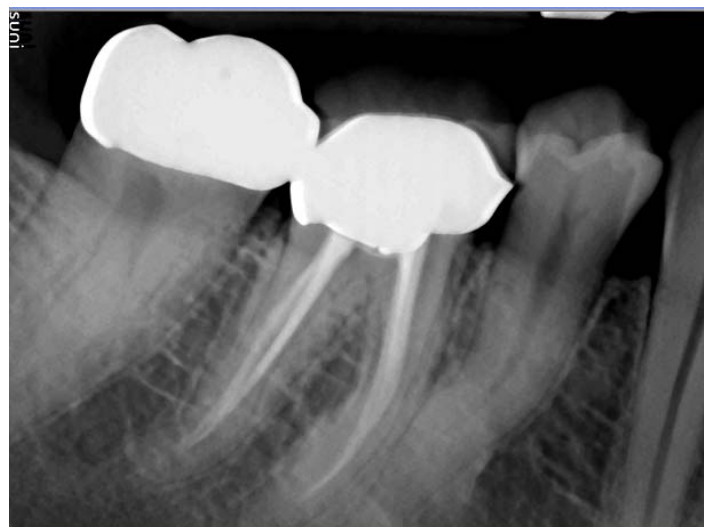
The following image as a result of Sharpening Factor set at 20, custom Mask Size of the Width at 41 and Height at 3.
